# INDOOR AIR QUALITY ASSESSMENT

Westminster Town Hall  
3 Bacon Street  
Westminster, Massachusetts

Prepared by:  
Massachusetts Department of Public Health  
Center for Environmental Health  
Emergency Response/Indoor Air Quality Program  
November 2005

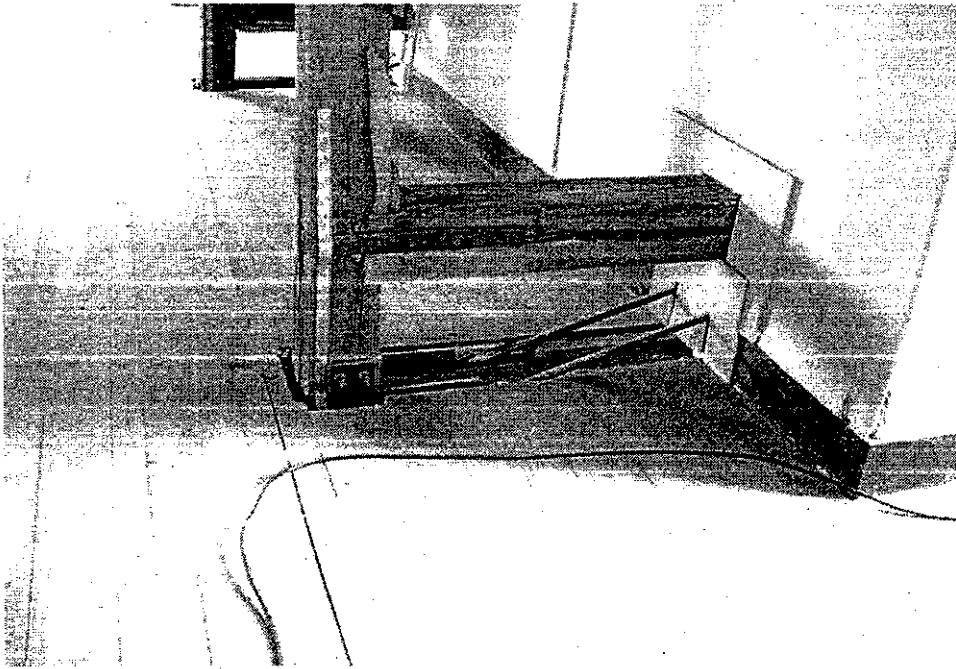
Picture 2

(Figure 1) (Picture 2). The mortise and tenon joints were held in place by a metal strap wrapped around the vertical beam and nailed into the horizontal beam with metal spikes (Picture 3). In this fashion, the outward thrusting of the roof rafters would be arrested by these horizontal/vertical beams.

**Wooden Horizontal Beam Inserted In Slot of Wooden Vertical Beam (Note Crack in Vertical Beam)**

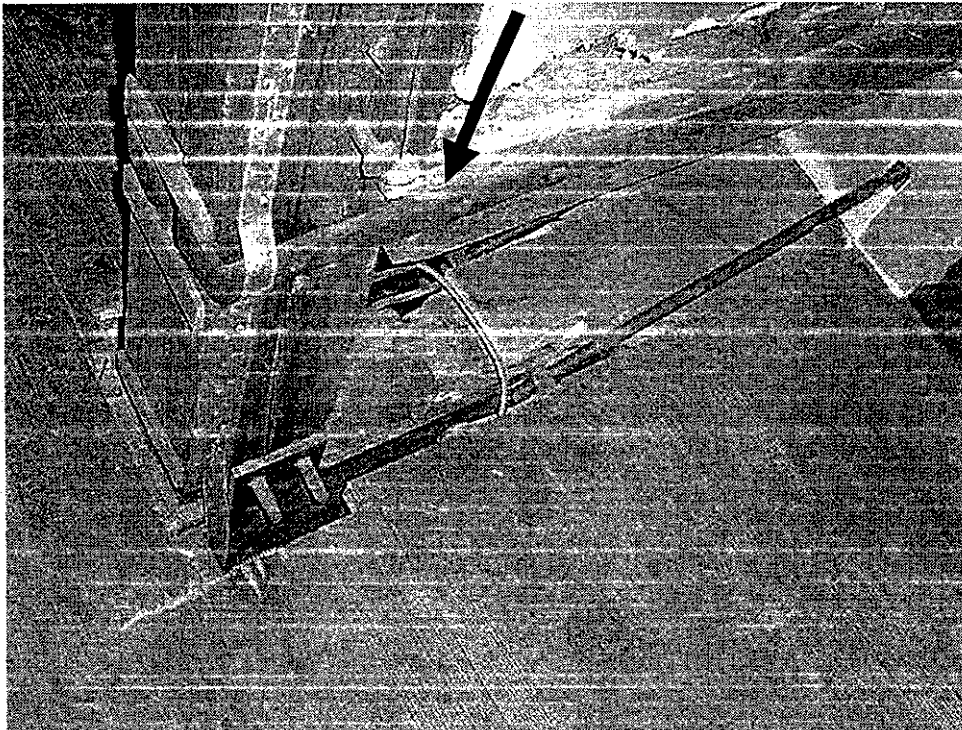
Picture 3

**Original Metal Strap Spiked Into Place That Holds Horizontal and Vertical Horizontal Beams Together**

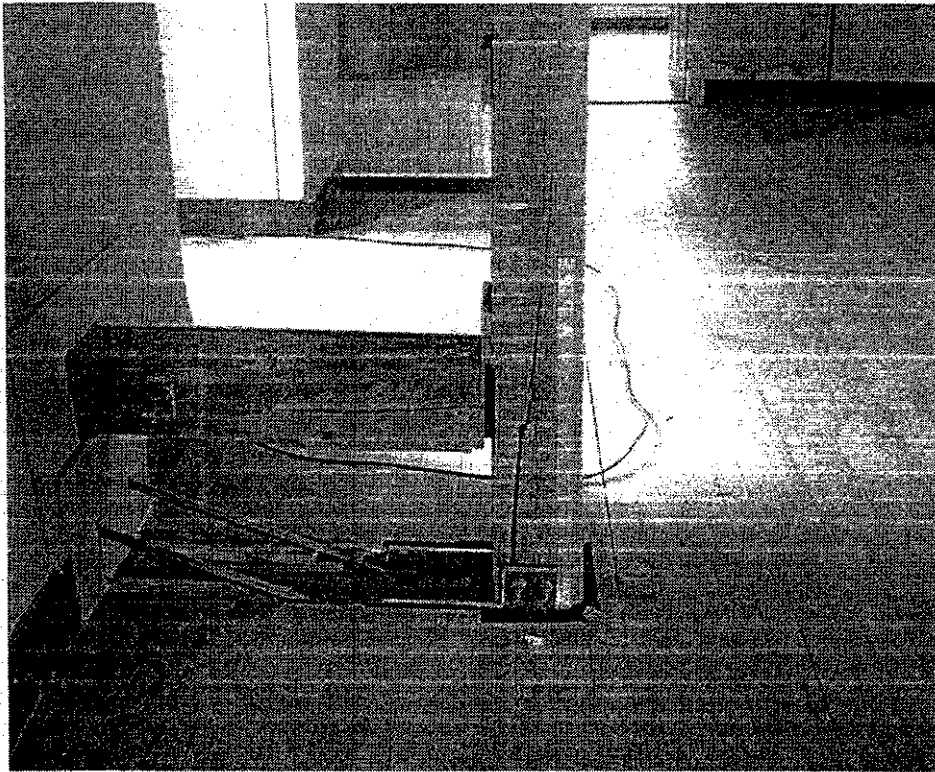
**Picture 4**

At some point previous to the assessment, a combination of heavy snow on the roof, combined with the weight of materials stored on the uppermost floor exceeded the capacity for the wooden vertical beams to carry load. This conclusion is supported by the following conditions noted in and outside the town hall.

- A number of vertical beams were either cracked at or around the iron strapping (Picture 4). Once a beam cracks, its ability to bear load is significantly reduced.

**Cracked Vertical and Horizontal Beam**

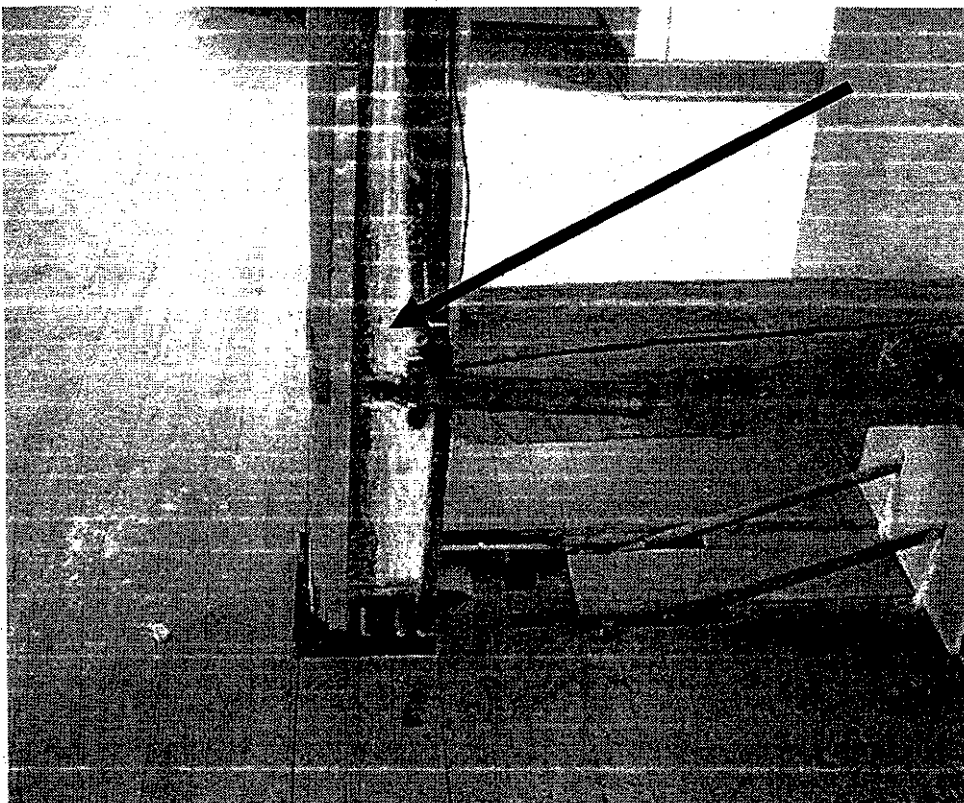
**Picture 5**

- One vertical beam had split entirely. It appears that a type of composite compound was applied to re-establish the integrity of the beam (Picture 5).

**Cracked Vertical Beam Reformed With Composite Compound (Arrow)**

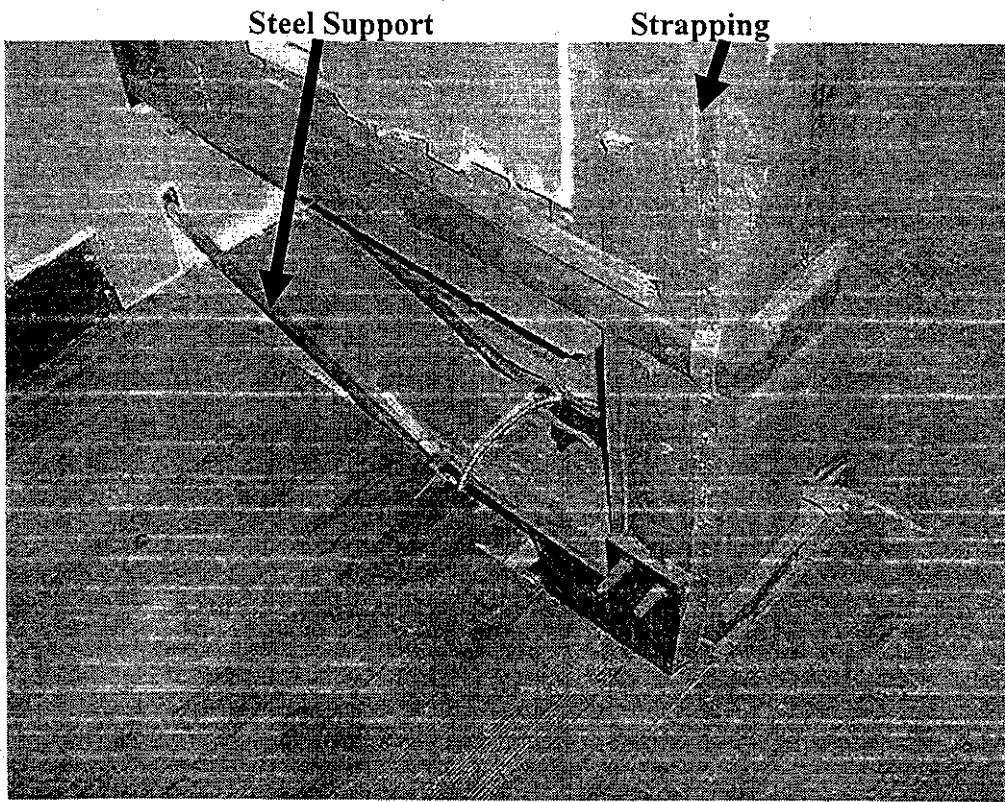
**Picture 6**

- Supplemental steel supports (Picture 6) appear to be connected to the roof edge to the vertical support beams.
- A gap, (estimated to be 2 inches) exists between the auditorium ceiling and gypsum wallboard (GW) used to subdivide the auditorium (Picture 7). Since GW has minimal elastic quality and is extremely susceptible to compression, this gap appears to have been created when the repairs to the beams raised the ceiling *upwards*.

**Supplemental Steel Supports and Strapping (Arrows) Installed To Reinforce Horizontal and Vertical Beams**

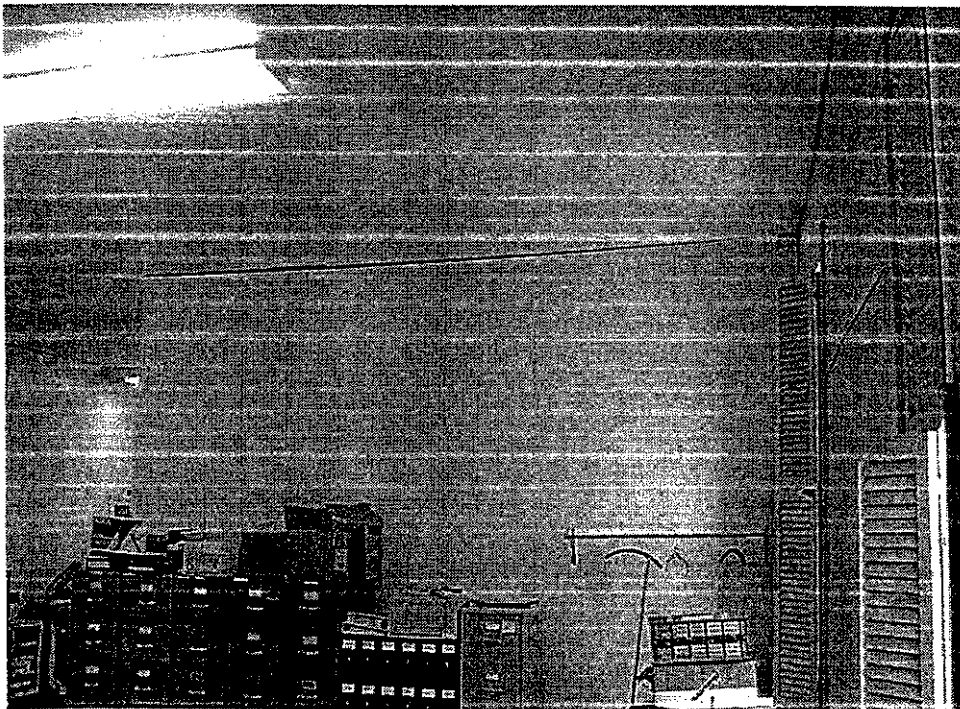
**Picture 7**

**Gap Created By Repair Lifting Ceiling**

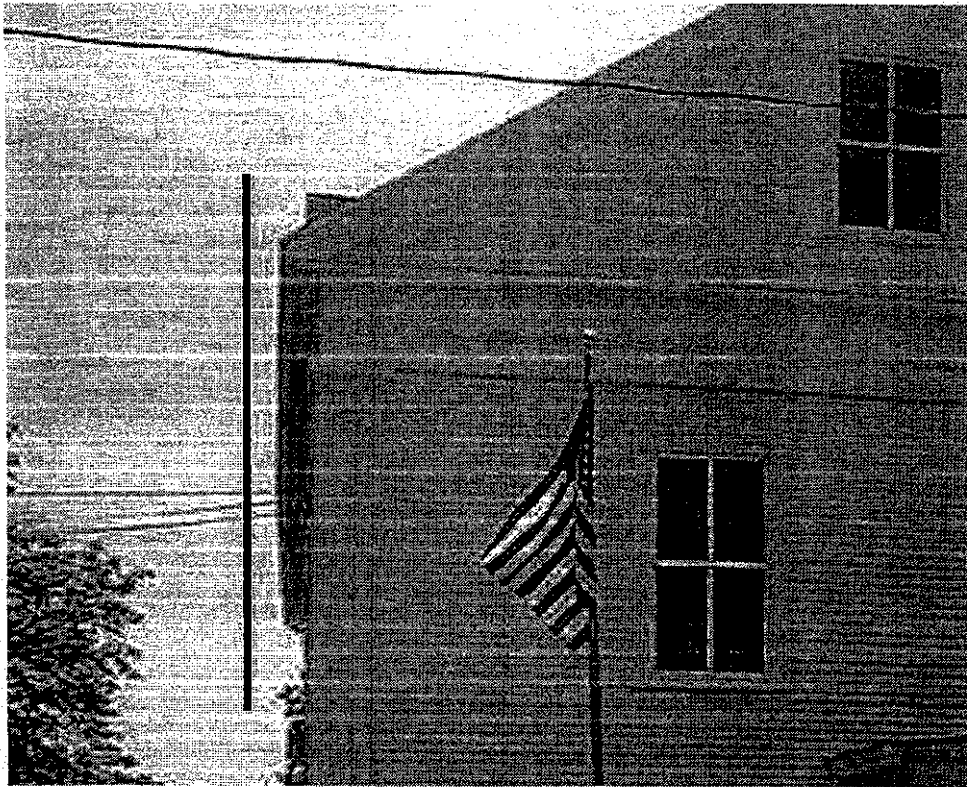
Picture 8

- The north second floor wall appears to bulge outwards when examined from the northwest corner of the building (Picture 8). This bulging roughly corresponds to the worst beam damage noted on the uppermost level.

Bulging Second Floor Exterior Wall/Roof Edge, North Side (Line Added As Visual Aid)

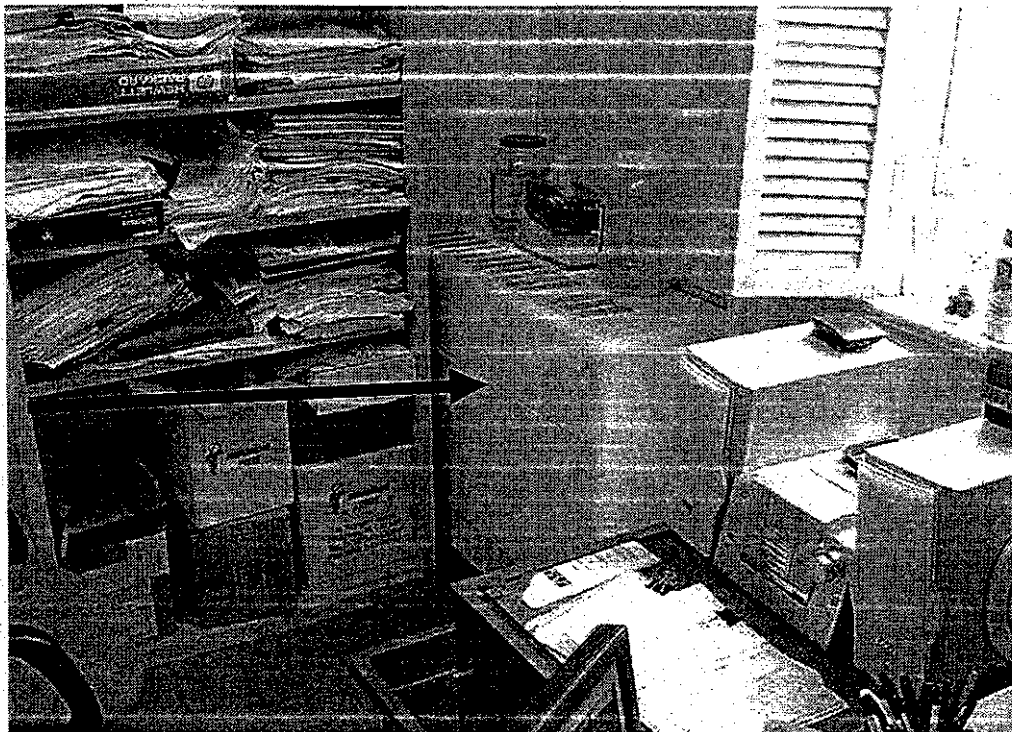
Picture 9

Univent with Wall Installed Over Casing

8. Remove all blockages from univents and exhaust vents.
9. Operate both supply and exhaust ventilation continuously during periods of occupancy.
10. Consider having ventilation systems re-balanced/calibrated every five years by an HVAC engineering firm.

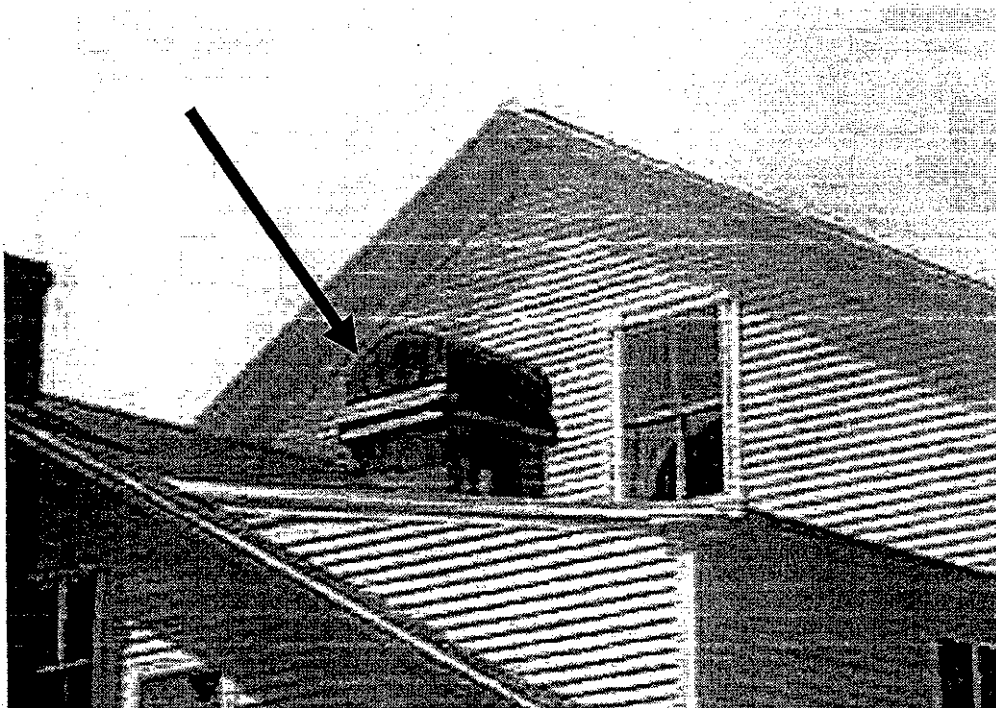
Picture 10

Exhaust ventilation in the first floor is provided by a ducted hallway vent which is likely connected to a fan above the furnace room (Picture 10). This vent was sealed with plywood (Picture 11) and the fan appeared to be deactivated. Without functional mechanical supply or exhaust ventilation, environmental pollutants can accumulate within the building and lead to poor air quality/comfort complaints. To maximize air exchange, the MDPH recommends that windows be used to provide airflow during business hours.

Exhaust Vent Housing on Roof

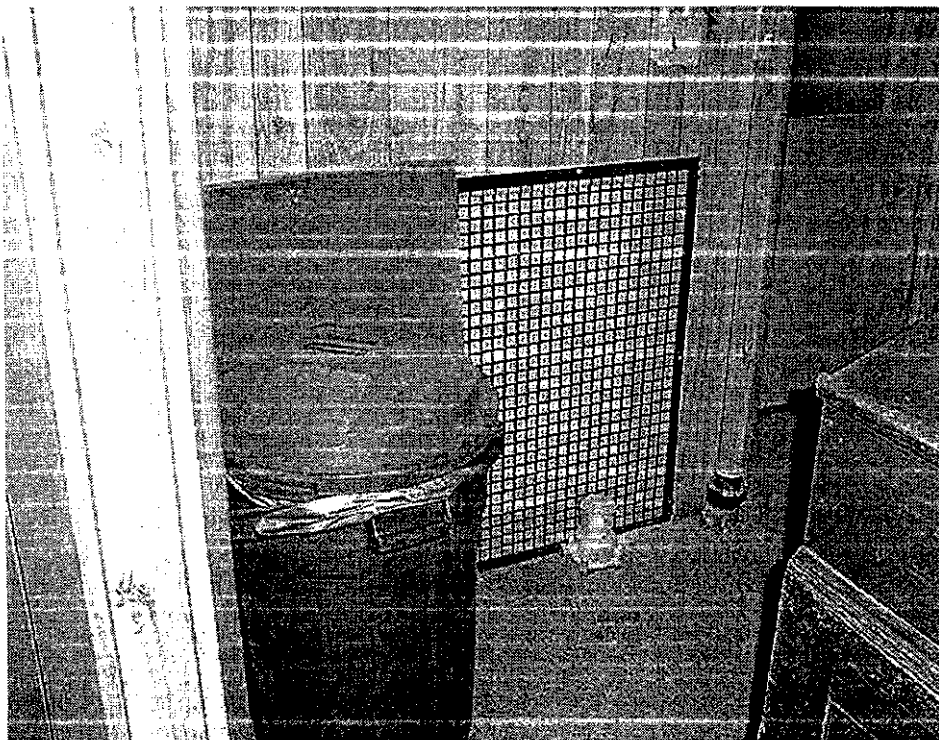
Picture 11

Exhaust Vent, First Floor, Note Plywood Blocking Vent

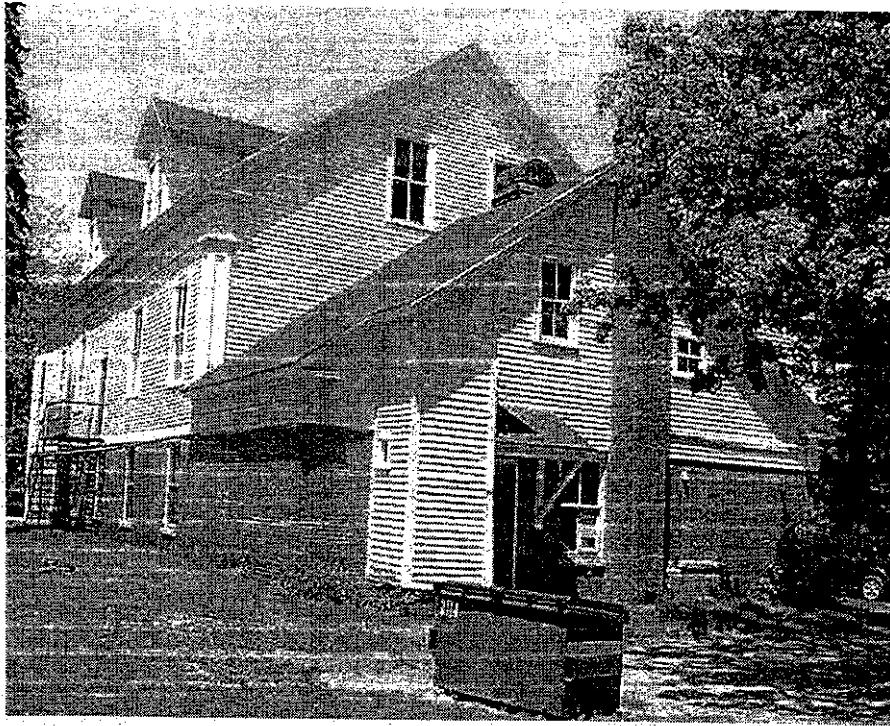
**Picture 12**

The absence of a gutter/downspout system (Pictures 12 and 13) may have a role in water accumulating in the building, particularly under the building commissioner's office. The exterior brick walls along the north side of the first floor are stained green with moss at approximately three feet above ground level, indicating chronic exposure to splashing rainwater from the non-guttered roof. Along the edge of the foundation of the town hall are a series of pits (Picture 14) as well as a tarmac apron. The purpose of these pits is to provide passive ventilation for the crawlspace to prevent odor and moisture accumulation. Each of these crawlspace vents was sealed with plywood and the seams caulked with foam insulation material (Picture 15). According to Board of Health personnel, the vents were sealed in this manner to prevent intrusion by pests (e.g., rodents). By blocking these vents, water vapor and other crawlspace pollutants will tend to vent *into* the building creating odors and moisten building components. In addition, buildings are normally constructed to allow for water to flow away from exterior walls, particularly if the building has a crawlspace or cellar. The purpose of the tarmac apron is to direct rainwater away from the exterior walls. The tarmac apron was buried under soil on the south wall and damaged along the north wall in a manner that allows for water to accumulate against the foundation (Pictures 16 and 17). In both instances, water is likely to accumulate against the exterior wall and penetrate the crawlspace.

**No Gutter/Downspout on Roof Edge, South Wall**

2. Remove plywood from crawlspace vents to enhance airflow. Install wire mesh over each opening to prevent pest infiltration.
3. Install a gutter and downspout system along the roof edge.

4. Until a gutter and downspout system can be installed, construct temporary, water proof shelters over each crawlspace vent to prevent water intrusion

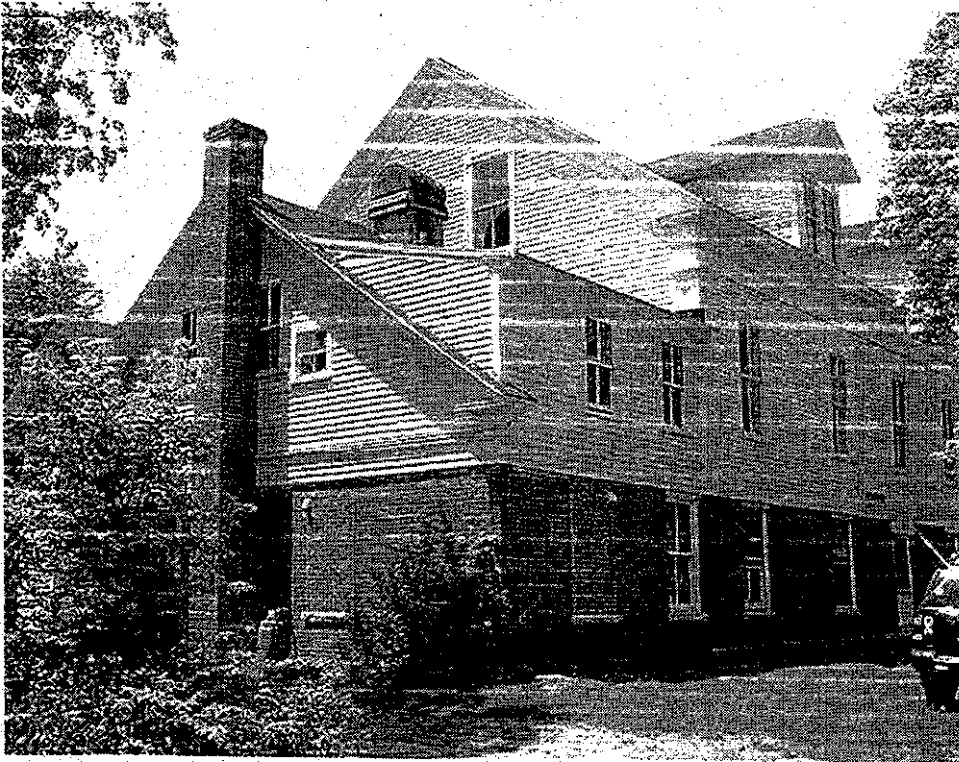
**Picture 13**

**No Gutter/Downspout on Roof Edge, North Wall**

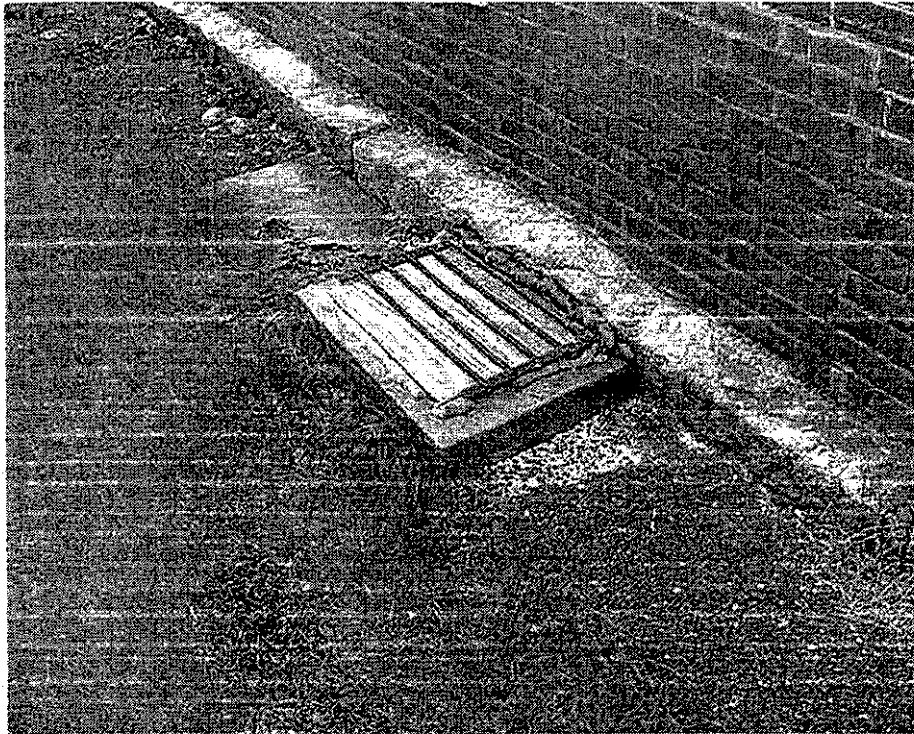
**Picture 14**

**Crawlspace Vent Pit at Base of the Building, Note Plywood and Sealant**

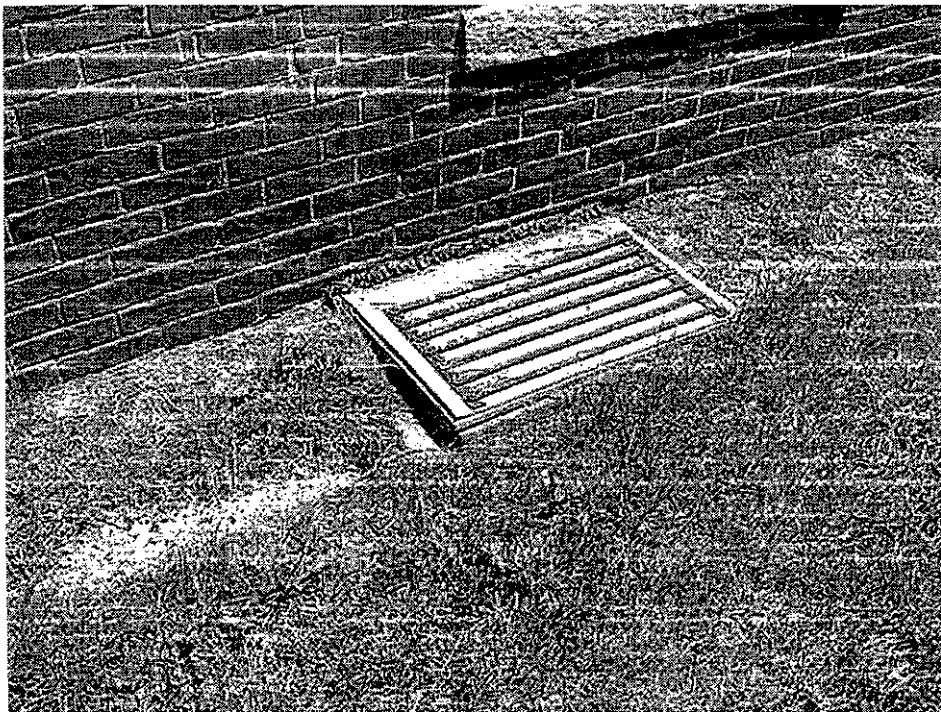
**Picture 15**

**Crawlspace Vent Sealed with Plywood and Sealant Adjacent to Building Commissioner's Office, Note Tarmac Apron Overgrown with Grass**

6. To prevent moisture penetration into the crawlspace, the following actions should be considered:
  - a. Reestablish the integrity and grade of the tarmac apron to drain rainwater from the foundation.

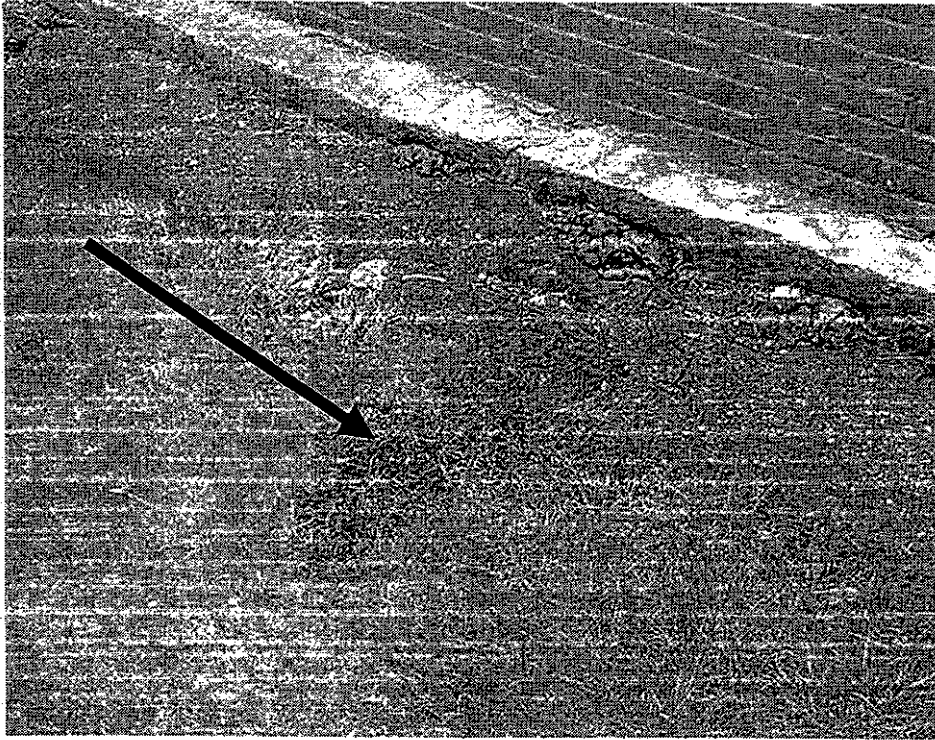
Picture 16

Damage Tarmac Apron, North Exterior Wall, Note Moss in Grass (Arrow) Indicating Heavy Water Exposure in This Area

- b. Remove foliage to no less than five feet from the foundation.
  - c. Improve the grading of the ground away from the foundation at a rate of 6 inches per every 10 feet (Lstiburek, J. & Brennan, T.; 2001).

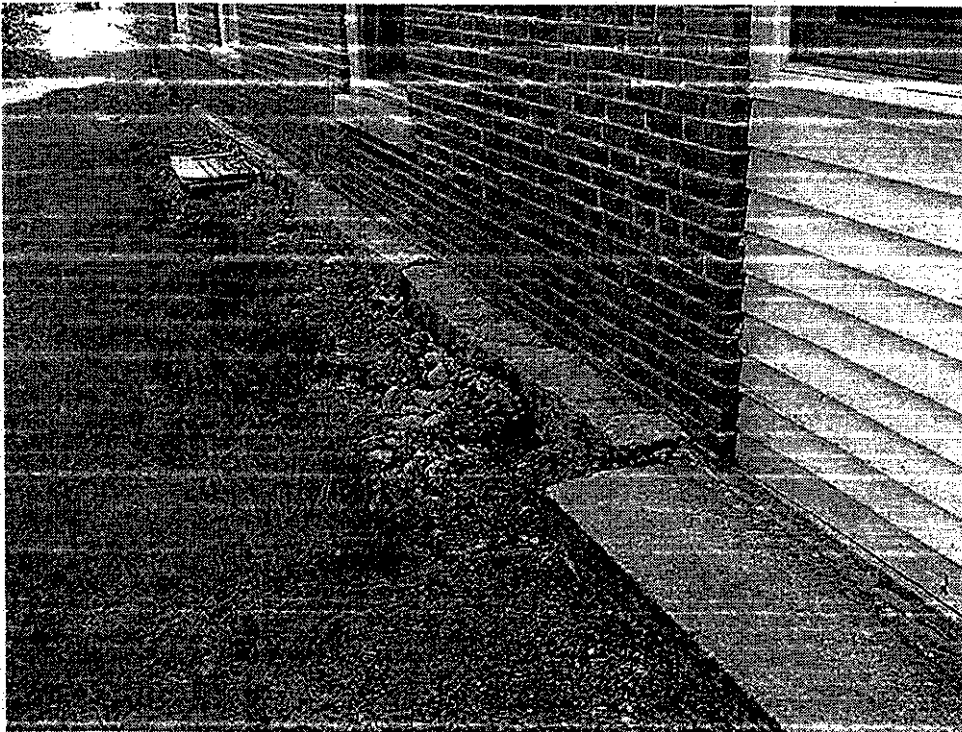
Picture 17

Damage Tarmac Apron, North Exterior Wall

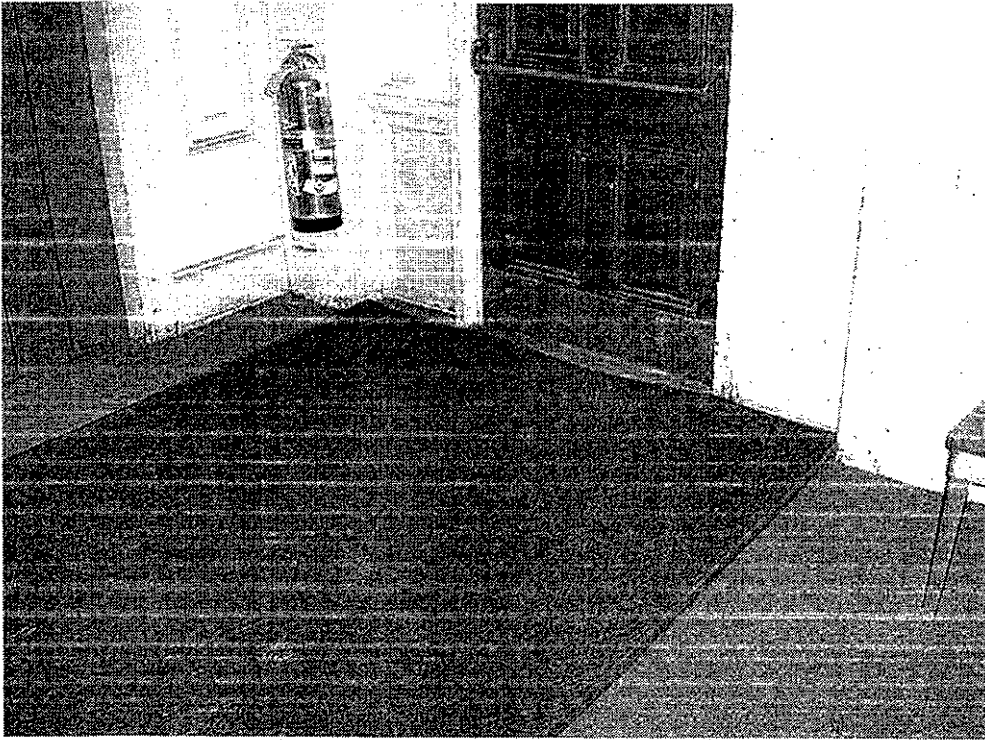
Picture 18

A musty odor was noted upon entering the town hall. A walk-off carpet exists at the main entrance, which is installed over wall-to-wall carpet (Picture 18). The rubber matting of the walk-off carpet tends to trap moisture and preventing the carpeting from drying. It is likely that the source of musty odors is the wall-to-wall carpet. Please note that the carpeting is installed over a tile floor. Old floor tile may contain asbestos and should be remediated in a manner consistent with Massachusetts asbestos laws.

Walk-Off Carpet On Top Of Wall-To-Wall Carpet, Front Lobby

13. Ascertain whether tile under carpet contains asbestos and remediate in a manner consistent with state and federal laws related to asbestos.
